**SUBJECT: Gurgling Noise from Dashboard Area**

**MODEL:** E38

**Complaint:** Gurgling or percolating noise coming from the dash.

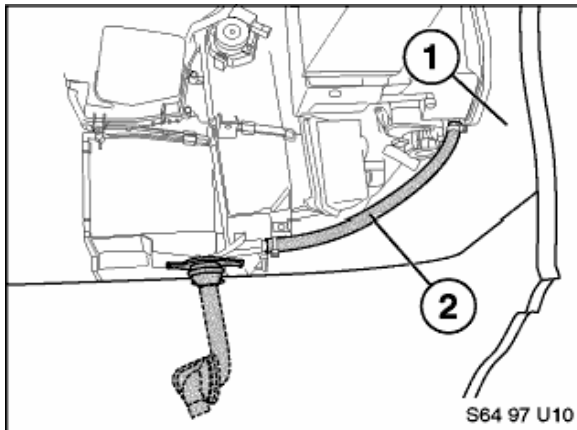
Here is the unmodified view of the fresh air drain tube(2) as seen on the passenger side. Take note of its close proximity to the firewall(1)

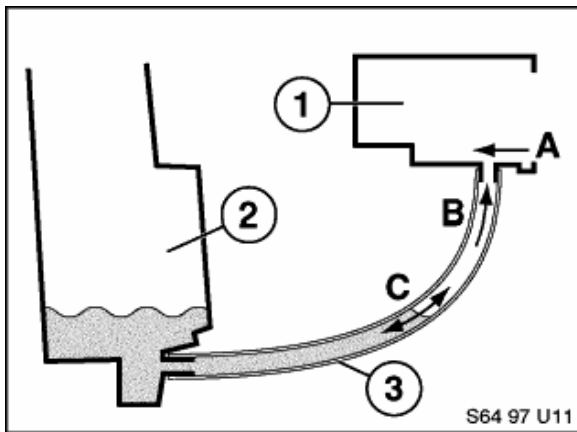
B) The condition described here is being caused by air flowing over the fresh air intake drain hole when the A/C control panel is not set to recirculation mode. This causes a vacuum to form at the inlet portion of the evaporator housing which allows any water or condensation that has formed in the housing to be sucked back up the fresh air hose, causing a gurgle or a percolating noise. As this noise is related to the amount of water or condensation present in the evaporator housing it will tend to show up mostly on hot/humid days, whereas the noise from the heater core can happen under most any conditions.

Seen here is a schematic of the condition being heard. Fresh air(A) is blowing into the fresh air cowling(1) which then causes a vacuum to form(B). The condensation in the evaporator housing(2) is forced back up the fresh air drain tube(3) allowing the condensation to go up and then splash back down as seen at C.
