SUBJECT **Wiring Harness Damage Causes Various Electrical System Faults**

MODEL E38 (7 Series) Vehicles produced up to February 21, 2000

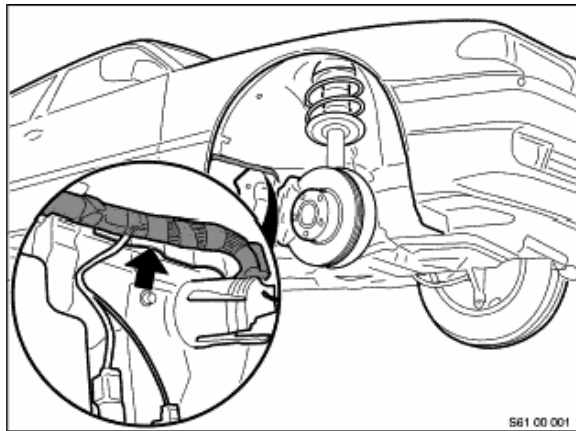
SITUATION Various faults can occur in the vehicle electrical systems. In some cases, the faults only occur intermittently. The warning lights or check control displays of the affected systems may be activated after the engine is started or while driving.

The wiring harness can be damaged by the metal panel (arrow) in the front-right wheel housing

1. Remove the front right wheel and inner wheel housing trim.

2. Expose the wiring harness (see illustration) from its retainers.
3. Remove the wiring harness tape in the area described (arrow).
4. Expose and carefully check the wires for damage to the insulation. If no damage can be detected, proceed with step 7.
5. Disconnect the vehicle battery.
6. Repair any damaged wires (refer to repair instructions 61 13... - Handling cables and crimping contacts).
7. Before reattaching the harness, wrap it along its length with insulating tape.
8. In addition, secure a foam support to the wiring harness with cable ties to prevent further wiring harness damage.
9. Secure the wiring harness so that it is tightly attached and free from the effect of vibration.
10. Reinstall the wheel housing trim and wheel.
11. Clear the fault memory.
12. Make a red mark next to the emission label - see illustration above.
