# Fiber optic method for health assessment of pipelines subjected to earthquake-induced ground movement

Branko Glisic and Yao Yao

Structural Health Monitoring

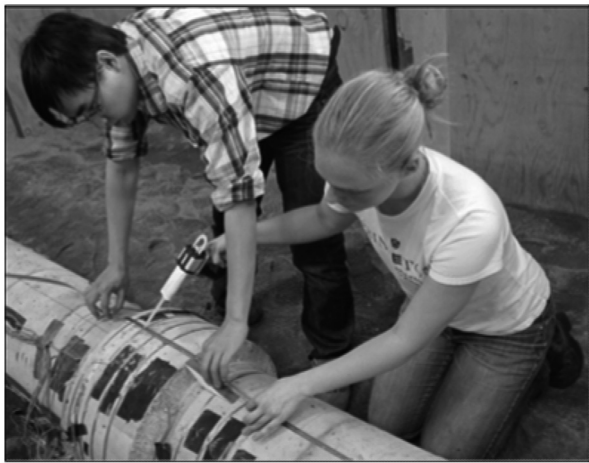
**Figure 8.** Gluing of sensors, detail at joint (second test).

The sensors installed on the pipeline are shown in Figure 7. The gluing of the sensors to the pipeline is shown in Figure 8. After the installation, the sensors were covered by duct tape, which provided with protection during the burying of the pipeline. Identical adhesives were used in the second test. The inspection of the sensors after the test has shown good adhesion of sensors over the body of the pipeline (no delamination)

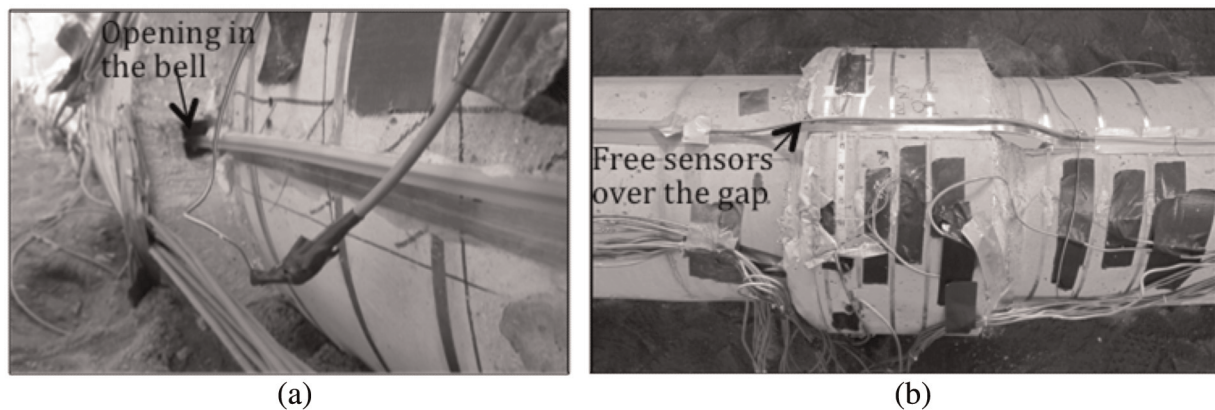
**Figure 11.** (a) First solution: opening in the bell, Profile sensor (up), and Tape sensor (down) and (b) second solution: free sensors over the gap, Tape sensor (closer), and Cord sensor (farther).

The validation tests fully proved the first solution, while the second solution was not satisfactory. Tape sensor installed in accordance with the second solution, being more fragile, was damaged by soil movements, and Cord sensor provided with ambiguous results. Consequently, only the first procedure is fully recommended, since the validation test confirmed its very good performance.

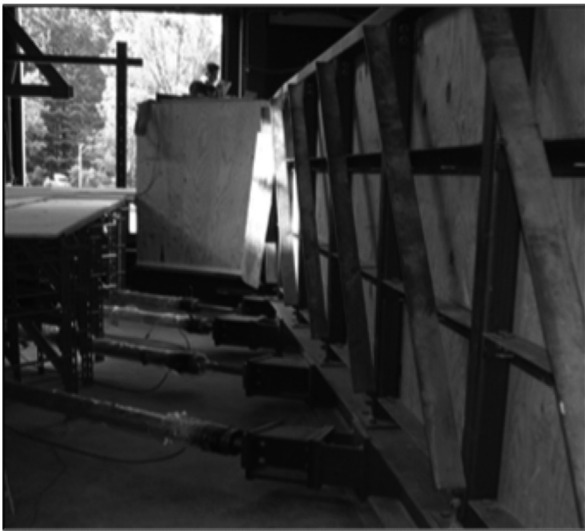
**Figure 13.** Hydraulic actuators.

For each test, a segmented concrete pipeline specimen was assembled in the basin and covered with the soil. Schematic view of the pipeline and the basin is given in Figure 12. The movable north part of the test basin was attached to four hydraulic actuators that were anchored in massive concrete counter bearings. During the test, the hydraulic actuators were used for controlled movement of the north part of the basin. The joint between the two parts was designed in a way that a transverse fault oriented  $50^\circ$  relative to the longitudinal length of the basin can be simulated (see Figure 12). The hydraulic actuators are shown in Figure 13.

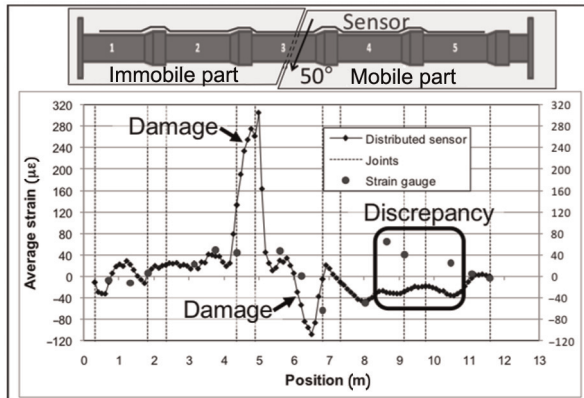
The results in the figure represent total noncompensated strain distribution along the pipeline. The temperature compensation was not necessary for damage

**Figure 15.** Results of test with detected damage (indicated by arrows) in the first test.

In the first test, the tape sensor at location L1 functioned properly during the first step of the test when relative ground displacement of 2.54 mm (1 in) was applied and damaged the pipeline at the joints 2 and 3 (the joint 2 belongs to pipe segment 2, i.e. it is between pipe segments 2 and 3, etc.). Unfortunately, during the second step, the sensor was broken as a consequence of inappropriate installation procedure (the use of “bridges,” see Figure 10). The results are presented in Figure 15.

Two unusual strain changes were observed, high tension close to joint 2 and high compression close to joint 3. These unusual strain changes actually correspond to locations of actual damage on the pipeline. No damage was detected at the other joints for 25.4 mm (1 in) displacement.

Tape sensor data were compared with strain gauge measurements, see Figure 15. The strain gauge sensors were not installed at the joints (their purpose was not damage detection), but over the body of the pipeline, next to the Tape sensor. The results obtained from two different systems are in a very good correlation, except in three points where some discrepancy is noticed (see Figure 15). This discrepancy is not fully explained, but part of it can certainly be attributed to the short gauge length of strain gauges.

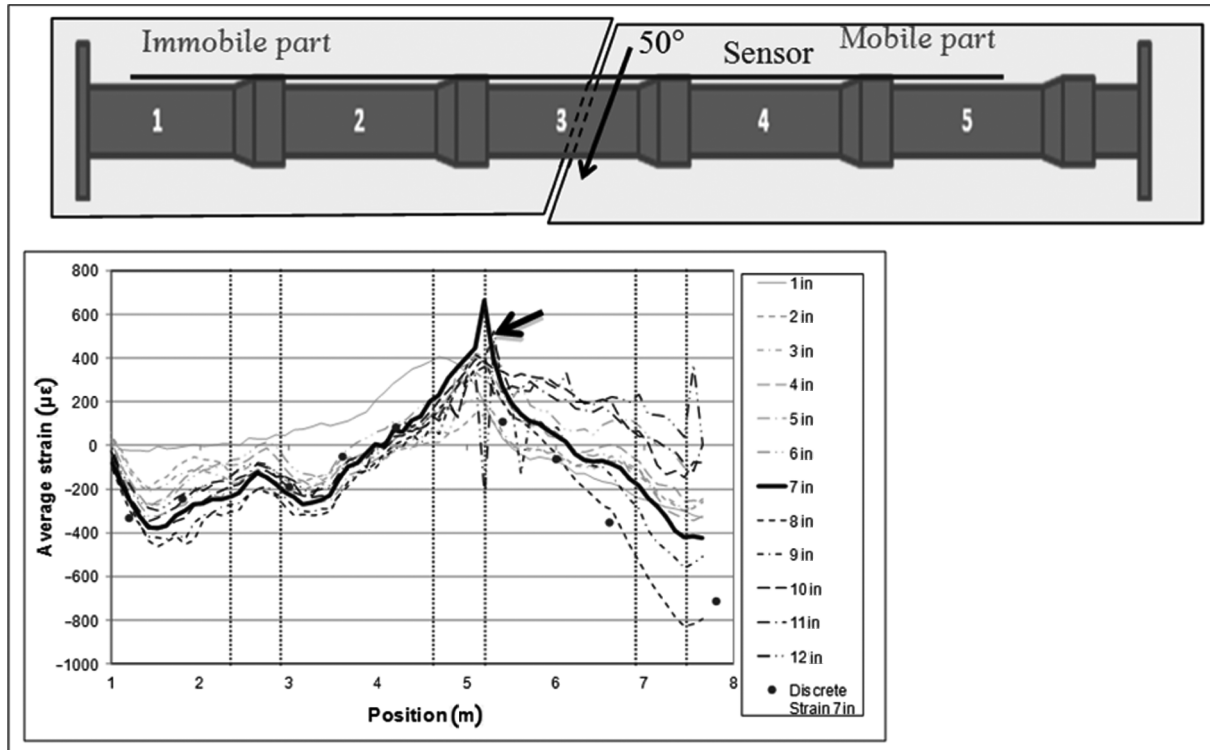
**Figure 16.** Results of test with detected damage (indicated by arrow) in the second test. Strain gauge values: courtesy of Prof. Lynch group at University of Michigan, Ann Arbor, Michigan.

Comparison with strain gauges has shown good agreement between the two technologies. For illustrative purposes, comparison of results for the seventh step of load is shown in Figure 16. The results demonstrated the ability of the system to detect and localize early damage in the form of cracks in close-to-real conditions and in real time.

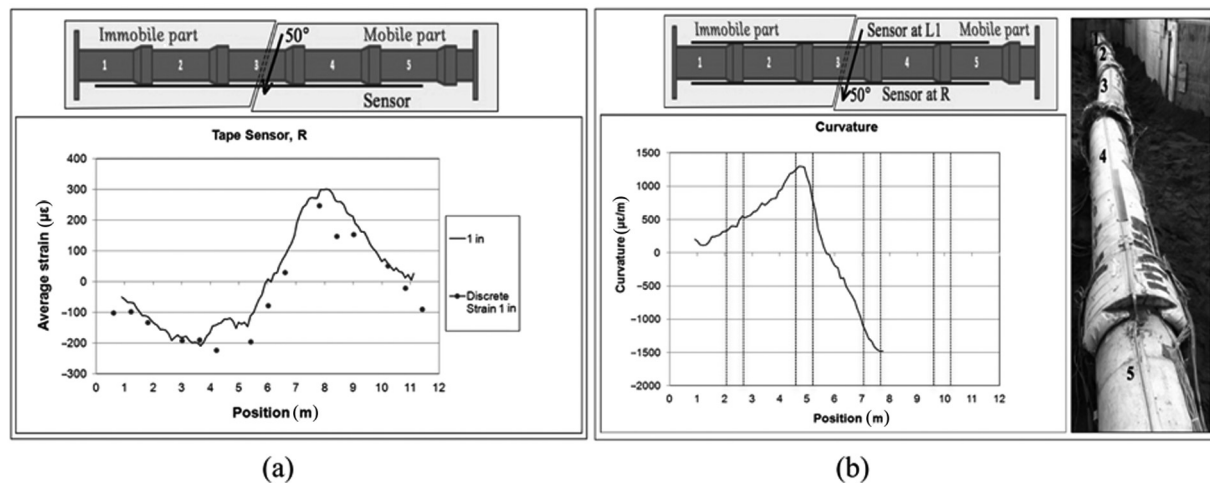
**Figure 17.** (a) Measurement result of Tape sensor at location R and (b) horizontal curvature calculated from measurements of Tape sensors at locations L1 and R and their correlation with the deformed shape of the pipeline. Strain gauge values: courtesy of Prof. Lynch group at University of Michigan, Ann Arbor, Michigan.

Tape sensor at location R functioned properly only during the first load step (25.4 mm displacement) in the second test and was broken afterward. The reason for sensor malfunction was similar as for the sensor at L1 location: delamination of measurement optical fiber from the tape (and not the installation procedures). Strain distribution at location R measured by the Tape sensor is presented in Figure 17. Comparison with strain gauges is presented in the same figure.

- Overall axial deformation of the pipeline is contraction;
- The pipeline is bended in the horizontal plane and deflected shape is qualitatively similar to deformed sinusoidal line (see strain distributions in Figures 16 and 17);
- The sensor at location L1 (see Figure 16) measures tension south of shear plane and compression north of shear plane, while the sensor at location R has exactly opposite behavior. This behavior is coherent with deformed shape presented in Figure 17;

- The distribution of horizontal curvature presented in Figure 17 is calculated from strain measurements as a ratio between the difference in strain (strain at L1 minus strain at R) and pipeline diameter; the pipeline body bends so that it has inflection point

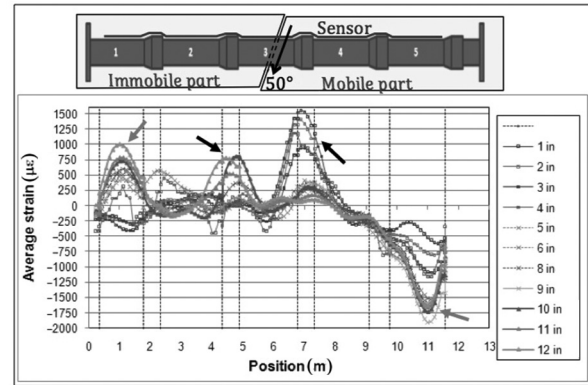
**Figure 18.** Cord sensor measurement at location L1 (on the pipeline) with detected damage (indicated by arrows in black) in the first test.

For higher levels of displacement, the damage detection can be performed more reliably, as high strain in diagram (marked by black arrows). However, sliding of the fibers makes impossible to qualitatively evaluate whether damage increased or not (e.g. strain in fibers for 11 in displacement is smaller than the strain for 10 in displacement), and in some cases can completely “mask” the damage (e.g. damage of joint 3 is not identifiable for 12 in displacement, while it was clearly noted for smaller displacements).

Two zones of concentrated high strain are noted at extremities of the pipeline, as shown by gray arrows in Figure 18. There was no visible damage at these locations and the measurement can be explained by both

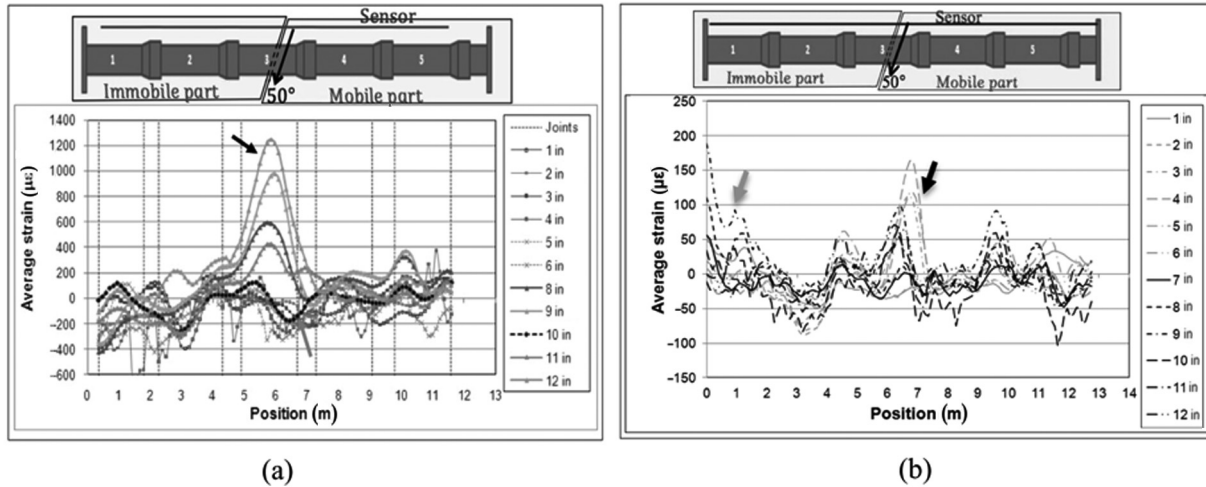
**Figure 19.** Cord sensor measurement at location L3 (in the soil) with detected damage (indicated by arrows in black): (a) first test results and (b) second test results.

Similar to the previous discussion, sliding of the fibers inside the sensor body occurred. In addition, sliding of the sensor with respect to the soil was also possible. Due to both sliding of the fibers and sliding of the entire sensor with respect to the soil, reliable detection and localization of the damage was possible only for higher values of ground displacement and by analyzing the time series of the measurements.

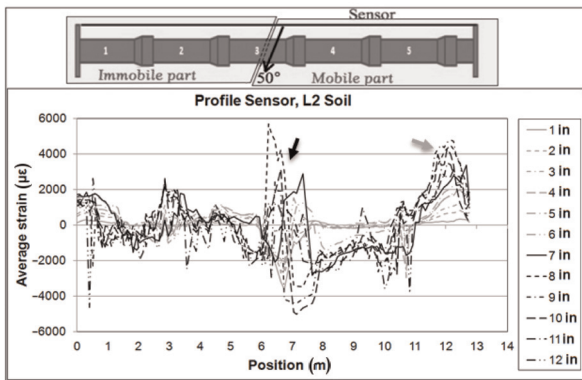
**Figure 20.** Profile sensor measurement at location L2 (in the soil) with detected damage.

The Profile sensor installed in soil at location L2 functioned properly for all 12 increments of the ground displacement in the second test. The measurement results are shown in Figure 20. Profile sensor successfully detected and localized soil displacement as indicated with black arrow in Figure 20. Noise in measurement was observed due to sliding of the sensor within the soil. Stressing of the sensor was detected at the

extremity of the pipeline due to sharp change in sensor geometry (gray arrow in the figure), for similar reasons as explained for Cord sensor in the first test. While the soil movement can be detected and localized using single measurement of Profile sensor, it is still recommended to confirm the detection and localization by analyzing time series of measurements.

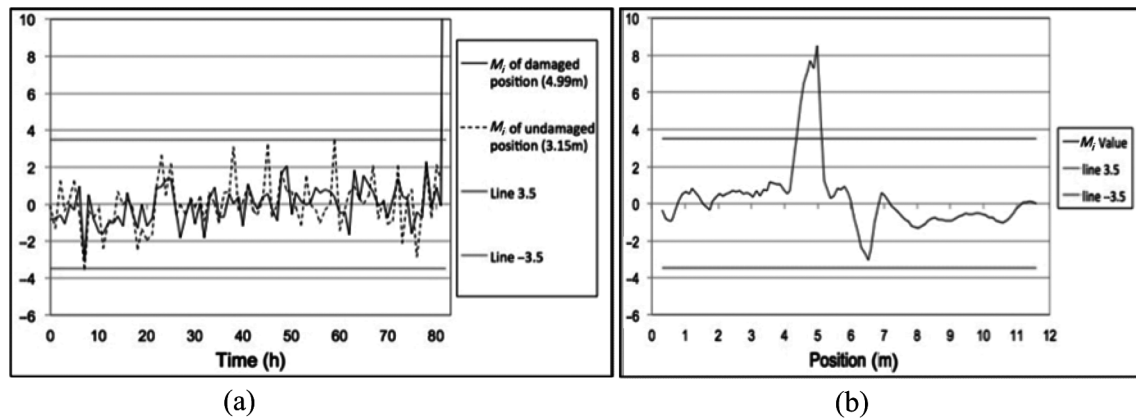
**Figure 23.** Application of Z-score method in (a) time and (b) space to the results shown in Figure 22(a) and (b); the damage is detected at joint 2 but not confirmed in joint 3, indicating that parameter  $M_i$  should be fine-tuned.

The examples of application of algorithms on the measurement results obtained during the tests are given in Figures 21 to 24. In both tests, the pipeline was monitored continuously for few days before the test, and this period is used as the learning period. Successful damage detection and localization based on algorithms confirm the potential of the method to be fully automated in real applications.

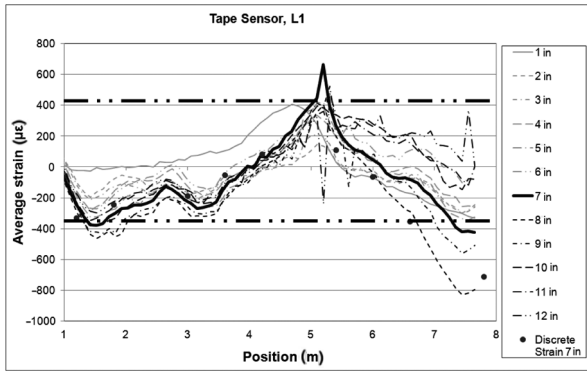
**Figure 24.** Absolute strain threshold damage detection for  $k = 3$  and  $\rho = 400 \mu\epsilon$  (second test, Tape sensor at location L1).

the ultimate strain limit of the monitored material (see example for  $k = 3$  and  $p = 400 \mu\epsilon$  in Figure 24). This detects slow strain changes that are undetectable by criteria such as those presented in point 1 above. Such degradations are nonetheless important as they can gradually reach critical levels.
