# Evaluation of a large-scale bridge strain, temperature and crack monitoring with distributed fibre optic sensors

Merit Enckell · Branko Glisic · Frank Myrvoll · Benny Bergstrand

**Keywords** Bridges · Field testing and monitoring · Maintenance and inspection

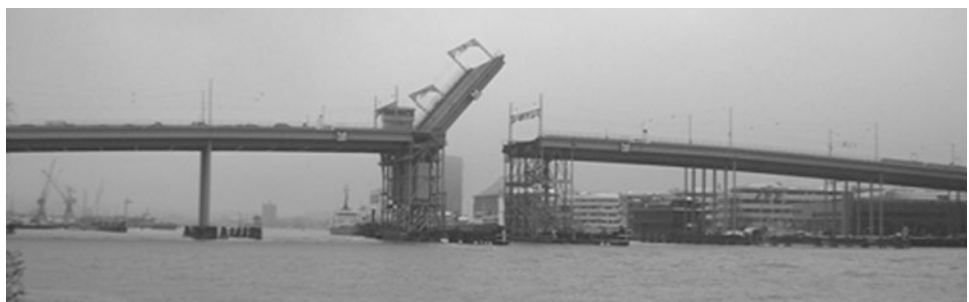
**Fig. 1** Side view of the Götaälv Bridge during bridge opening

The Götaälv Bridge, built in 1936–1939, is a large steel girder structure with a concrete bridge deck combined for both road and light-rail traffic as well as pedestrian and bicycle lanes, see Fig. 1. The length of the bridge is about 950 m and seven continuous steel girders are supported on more than 50 columns. The bridge is the important connection between Hisingen and Gothenburg City and around 25,000 vehicles and 3,800 bicycles pass the bridge everyday [2, 13]. The 20-m wide navigation channel has a vertical clearance of 30 m. The dense light-rail traffic causes dynamic effects and the bridge openings cause a lot of unsymmetrical static loads during boats transits, especially in rush hours.

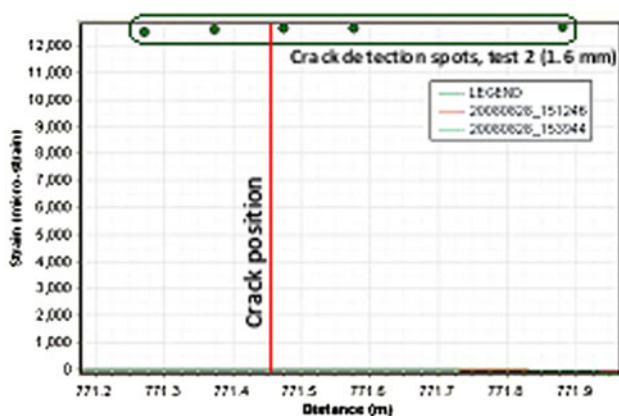
**Fig. 9** Crack test 2: detected “crack spots” seen with an opening of 1.6 mm

produced noise. The crack was detected, correctly localised and warning message was correctly sent. Five crack detection spots over 12,000 micro-strains were shown in the measurement plot. Therefore, test 2 behaviour showed the expected outcome, see Fig. 9.

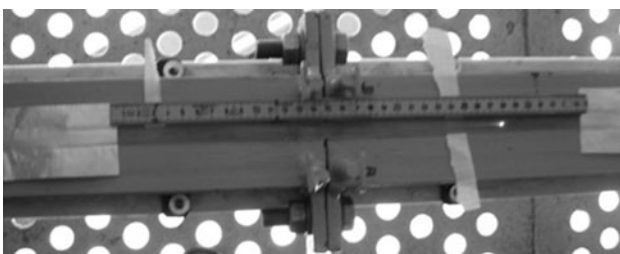
**Fig. 10** Crack test 3: delamination from the gap to both sides marked with portion of paper and fibre breakage seen as a glowing spot to the right of the gap

The gap was rapidly opened to 3.3 mm, simulating the crack of the same magnitude. Delaminating was noticed by produced noise. It was also measured and delamination east of the gap was 12.5 cm and 10.5 cm west of the gap. The total delamination length was 23 cm. Breakage of the optical fibre inside SMARTape was caused by this opening approximately 13.5 cm west of the gap. Although the optical fibre was broken, it was possible to complete the measurement since the light could pass through the breakage point. Due to reflection in breakage point, it was impossible to perform correct strain measurement and direct crack detection around the breakage point, but at that point signal saturation occurred. The signal saturation is recognised by the system as extremely high value of strain (at the limits of range); the crack was detected indirectly as extremely high absolute value of strain.

Delaminating started at paint–steel interface in the gap area, but then propagated to glue–sensor interface. SMARTape sensor is shown in Fig. 10. Portion of paper was inserted in both sides between sensor and glue in order to illustrate extremities of delaminated section. The fibre breakage point is also clearly visible as a glowing, bright spot on the right side of the figure.
