The Built Environment 3

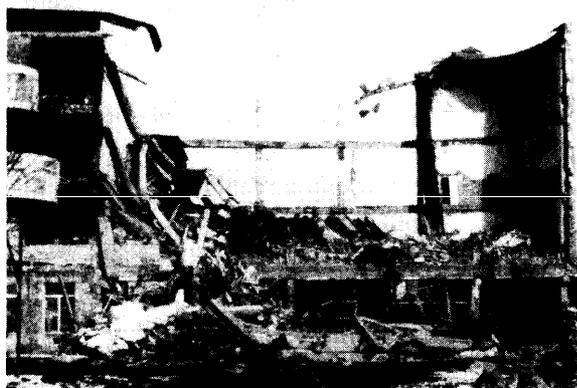
Earthquakes can severely damage buildings.

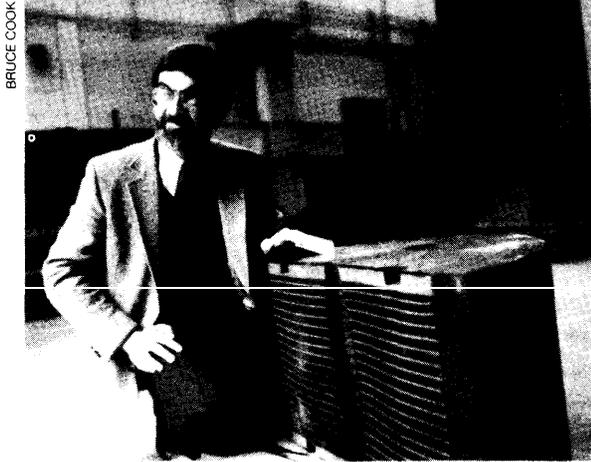
A base isolator cut in half to show its construction.

Rather than the usual method of stiffening a building to resist seismic damage, base isolation in effect disconnects the building from the ground. This allows the ground to move underneath the building while the building stays relatively still. If successful, base isolation can protect both the building and its contents. There are two principal techniques for base isolation:

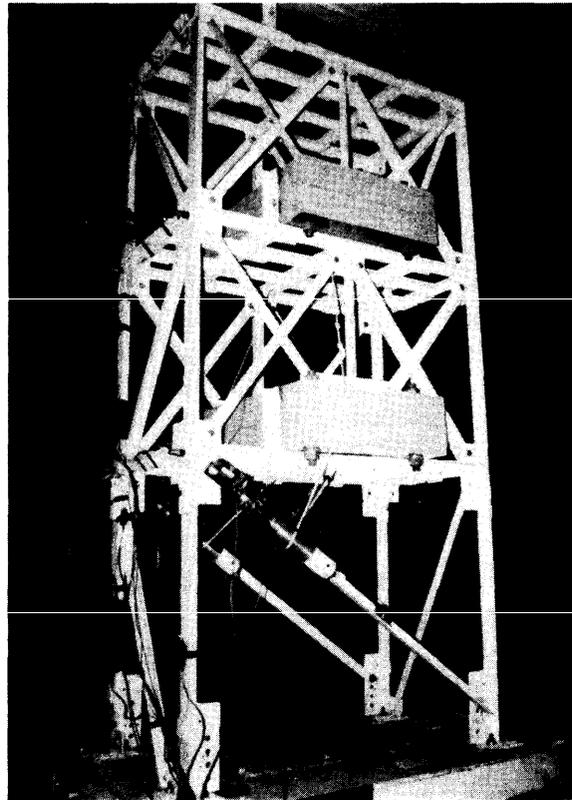
Active control systems being tested.

Another approach to minimizing earthquake damage is the use of active control systems, which detect earthquakes and respond to them. Although many ideas for active control are still at the conceptual stage, some are beginning to be applied in buildings. Perhaps the simplest example of active control is the use of a large weight on the top of a building; the weight is computer-controlled to move so as to counteract the earthquake-induced sway of a building. This technique, known as “active mass damping,” is already used in some tall buildings, including the John Hancock Building in Boston, to reduce occupant discomfort from wind-induced building sway.³¹ Such a system has been installed in an office building in Japan to resist seismic damage.³²

A more advanced approach is the use of “active tendons” — electronically controlled actuators that can be instructed to shake the frame of a building so as to minimize earthquake-induced movement. These systems, although still far from commercial application, have the potential to reduce both structural and contents damage by mini-

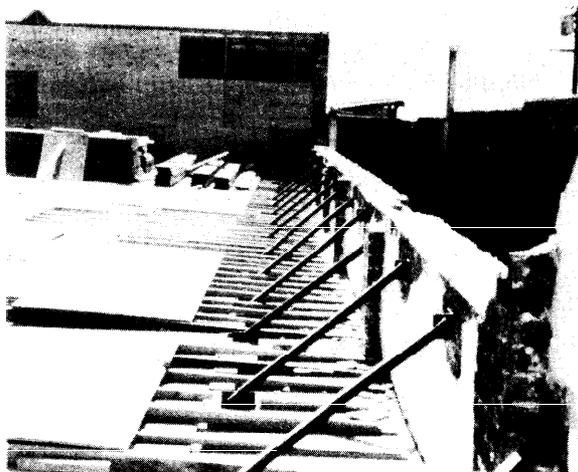
Bracing parapets can reduce damage and injuries.

There are generally agreed-on principles that can guide retrofitting. For example, typical steps to reduce damage include bracing parapets; improving connections among walls, floors, and roofs; strengthening the walls themselves; adding structural framing to support exterior walls; and modifying the building design to reduce asymmetry (symmetric buildings are generally stronger). Work to refine these techniques is ongoing. Its goal is to develop a set of comprehensive guidelines on seismic retrofitting of existing buildings.³⁴

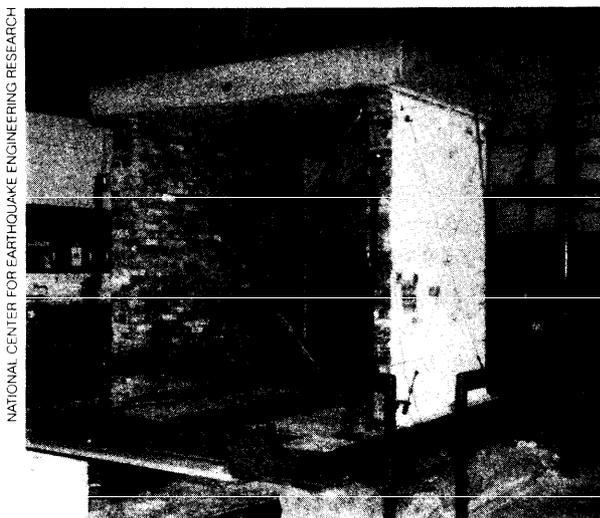
Testing of URM retrofit methods
