ELECTRON-BEAM-INDUCED-CURRENT (EBIC) IMAGING OF  
DEFECTS IN  $\text{Si}_{1-x}\text{Ge}_x$  MULTILAYER STRUCTURES

J.C. STURM, X. XIAO, P.M. GARONE, and P.V. SCHWARTZ  
Department of Electrical Engineering, Princeton University  
Princeton, N.J. 08544

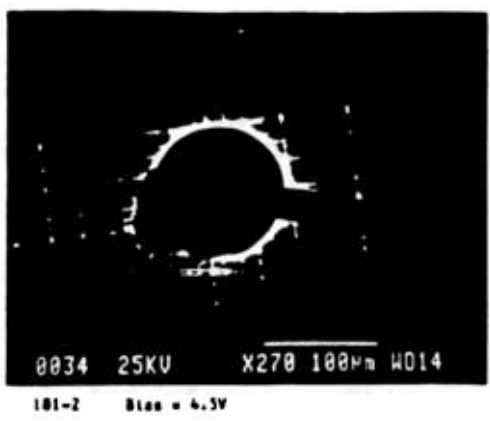
Fig. 3. EBIC image of the 0.17 um sample after thinning and with a bias of 4.5 V.

To investigate this anomaly, we etched away approximately half of the top Si cap (down to  $\sim 0.6 \mu\text{m}$ ) on an unused piece of the 0.17 sample by careful plasma etching. Schottky barrier structures were then fabricated as before. EBIC measurements with no bias on these structures showed no defects as in fig. 2 (a). A reverse bias was then applied to the Schottky barrier to extend the Schottky barrier depletion region to the  $\text{Si}_{0.78}\text{Ge}_{0.22}:\text{Si}$  interface. Under such bias conditions, extended line defects (presumably misfit dislocations) were seen, with a spacing on the order of 10  $\mu\text{m}$  (fig 3). Plan view TEM measurements performed on the sample also showed line defects, although with a spacing a factor of 10 closer. This discrepancy could be caused by the very variable spacing of dislocations within a sample and the small area sampled by TEM (about 2 square microns in this case), or could result if some dislocations were not electrically active (and hence gave no EBIC signal.) In any case, these measurements confirm that dislocations are present in the structure, and that the critical thickness is less than 0.17  $\mu\text{m}$ , consistent with other work reported in the literature.
